# Health and Condition Report

## Brimbank City Council

Report on five significant *Quercus canariensis* (Algerian Oak) trees throughout H.V. McKay Gardens, Sunshine

22 November 2010

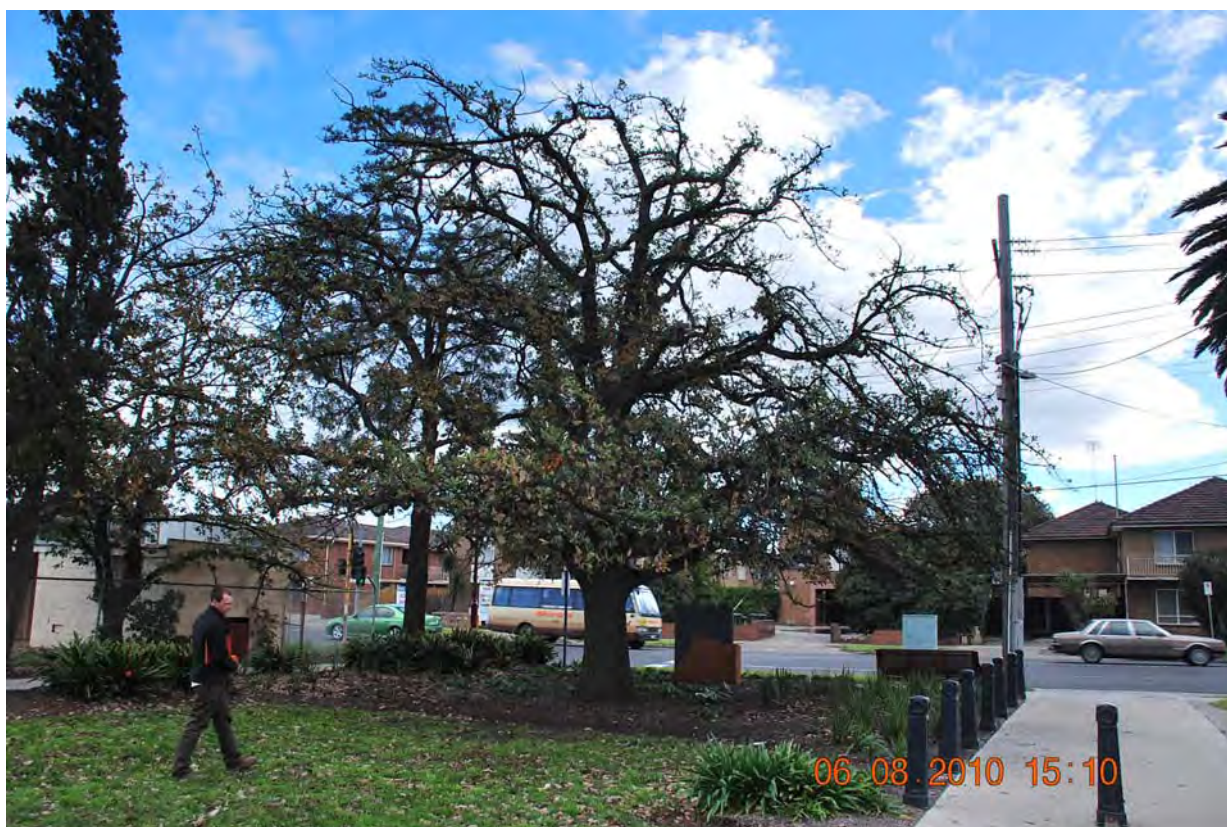
Tree Number	6783
Botanical Name	<i>Quercus canariensis</i>
Common Name	Algerian Oak
Origin	Exotic
Canopy Dimensions (HxW)	10 m x 14 m
Diameter at Breast Height	76cm
Health	Very Poor
Structure	Good
Useful Life Expectancy	5-10 years
Landscape Contribution	High
Individual Significance	Valuable

Figure 1: Tree 6783, is showing signs of severe stress

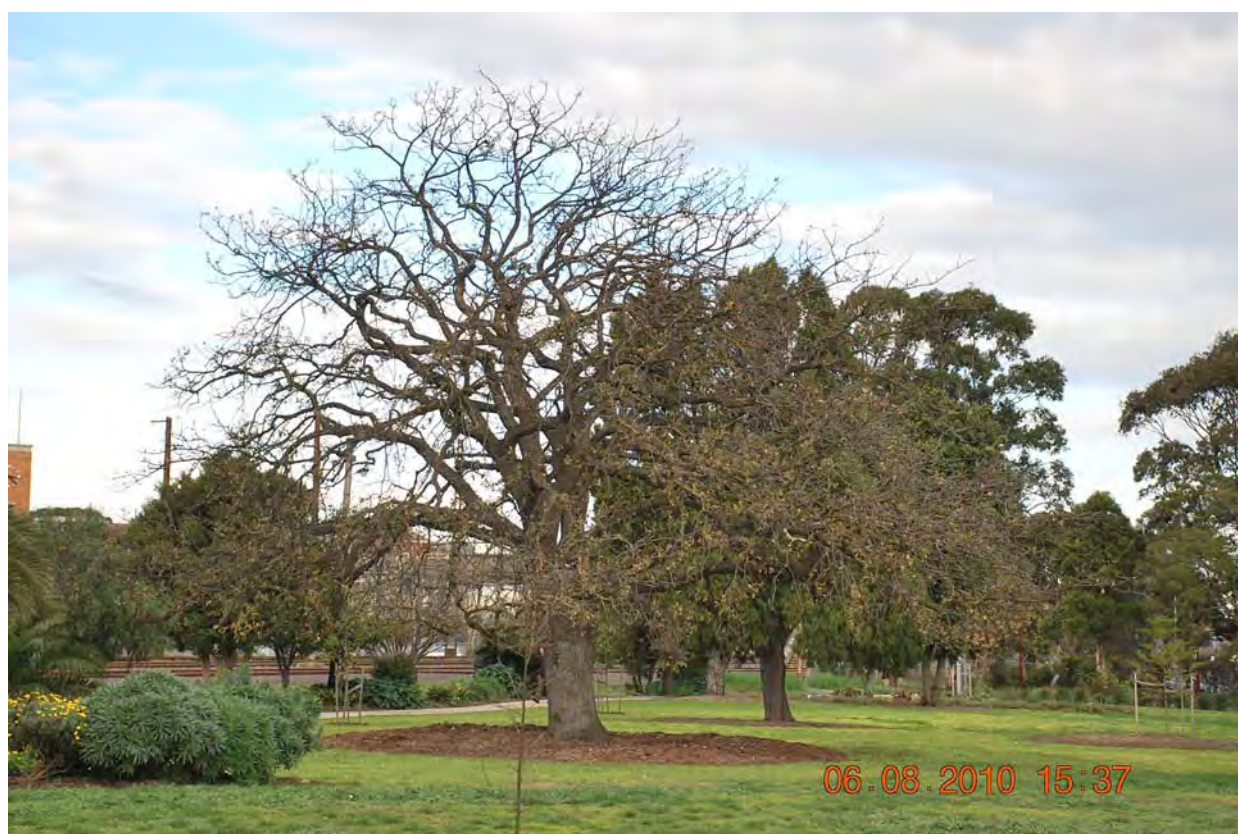
Tree Number	6788
Botanical Name	<i>Quercus canariensis</i>
Common Name	Algerian Oak
Origin	Exotic
Canopy Dimensions (HxW)	11 m x 16 m
Diameter at Breast Height	87cm
Health	Very Poor
Structure	Good
Useful Life Expectancy	20-40 years
Landscape Contribution	High
Individual Significance	Valuable

Figure 2: Tree 6788, is showing signs possum predation

Possum predation within the canopy of the trees' and particularly within Tree 6788, have further exacerbated the current stress most likely caused by the current drought conditions.

All of the mature *Quercus canariensis* show signs of possum predation and Tree 6788 is under severe stress due to the degree of predation.

3. Apply slow release, nitrogen rich fertiliser to soil surface
4. Control possums through a tree banding and integrated pruning program
5. Remove excess mulch under Tree 6788
6. Apply mulch under each of the trees using 'arboricultural mulch' not woodchips
  - 6.1 The mulch needs to be a mixture of wood, bark and foliage to encourage formation of humus (organic matter)
7. Introduce worms to the mulched areas
  - 7.1 Worm eggs and juveniles are available at most larger nursery's such as Bunning's Warehouse for approximately \$50.00 per 1000 (250gm) worms)

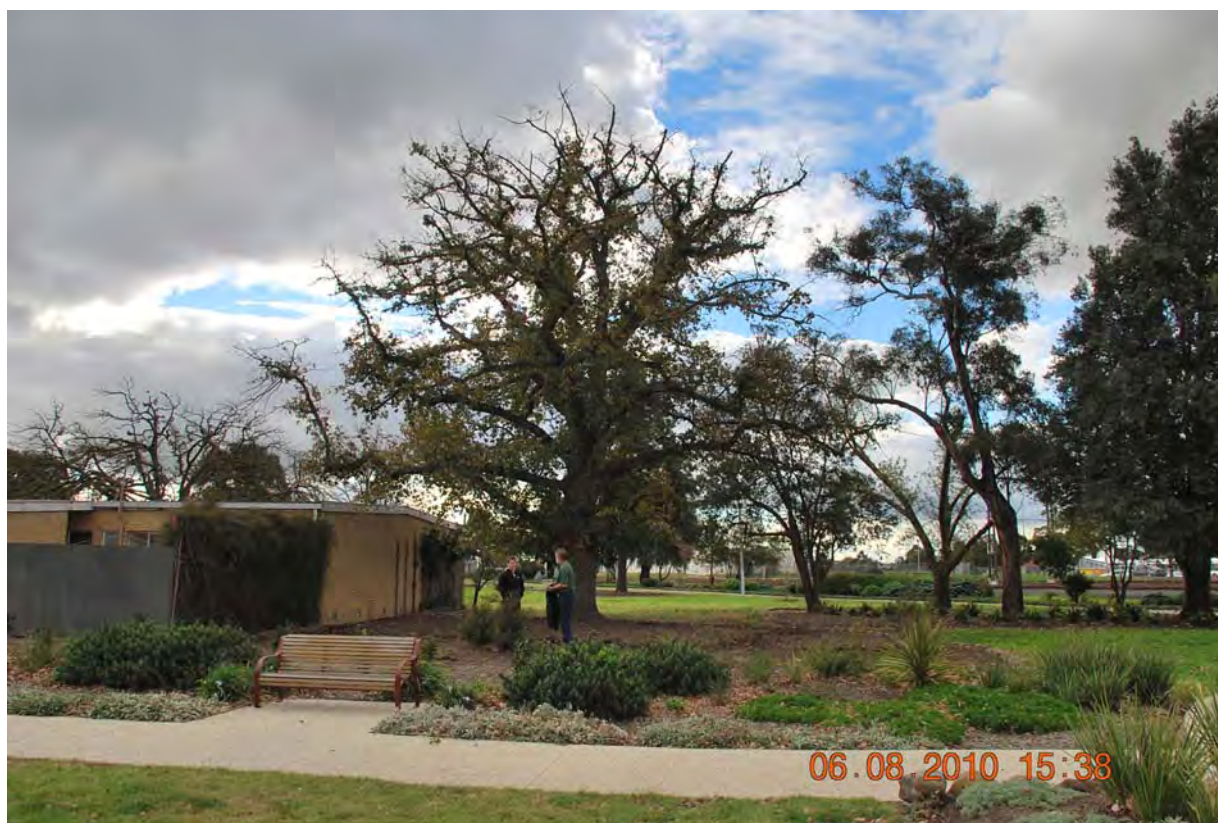
Figure 3: Tree 40311

Tree Number	40311
Botanical Name	<i>Quercus canariensis</i>
Common Name	Algerian Oak
Origin	Exotic
Canopy Dimensions (HxW)	14 m x 15 m
Diameter at Breast Height	106cm
Health	Very Poor
Structure	Good
Useful Life Expectancy	20-40 years
Landscape Contribution	High
Individual Significance	Valuable

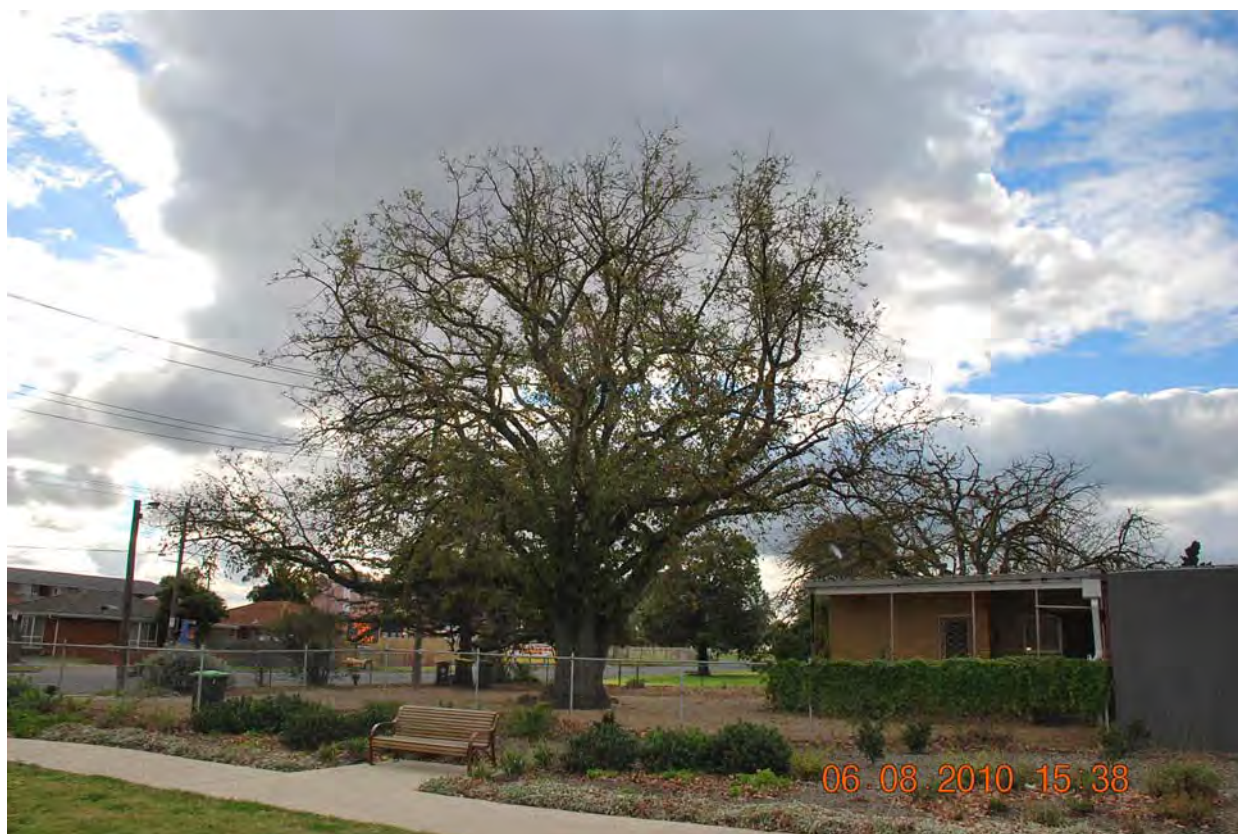
Tree Number	66971
Botanical Name	<i>Quercus canariensis</i>
Common Name	Algerian Oak
Origin	Exotic
Canopy Dimensions (HxW)	15 m x 20 m
Diameter at Breast Height	120cm
Health	Very Poor
Structure	Good
Useful Life Expectancy	20-40 years
Landscape Contribution	High
Individual Significance	Valuable

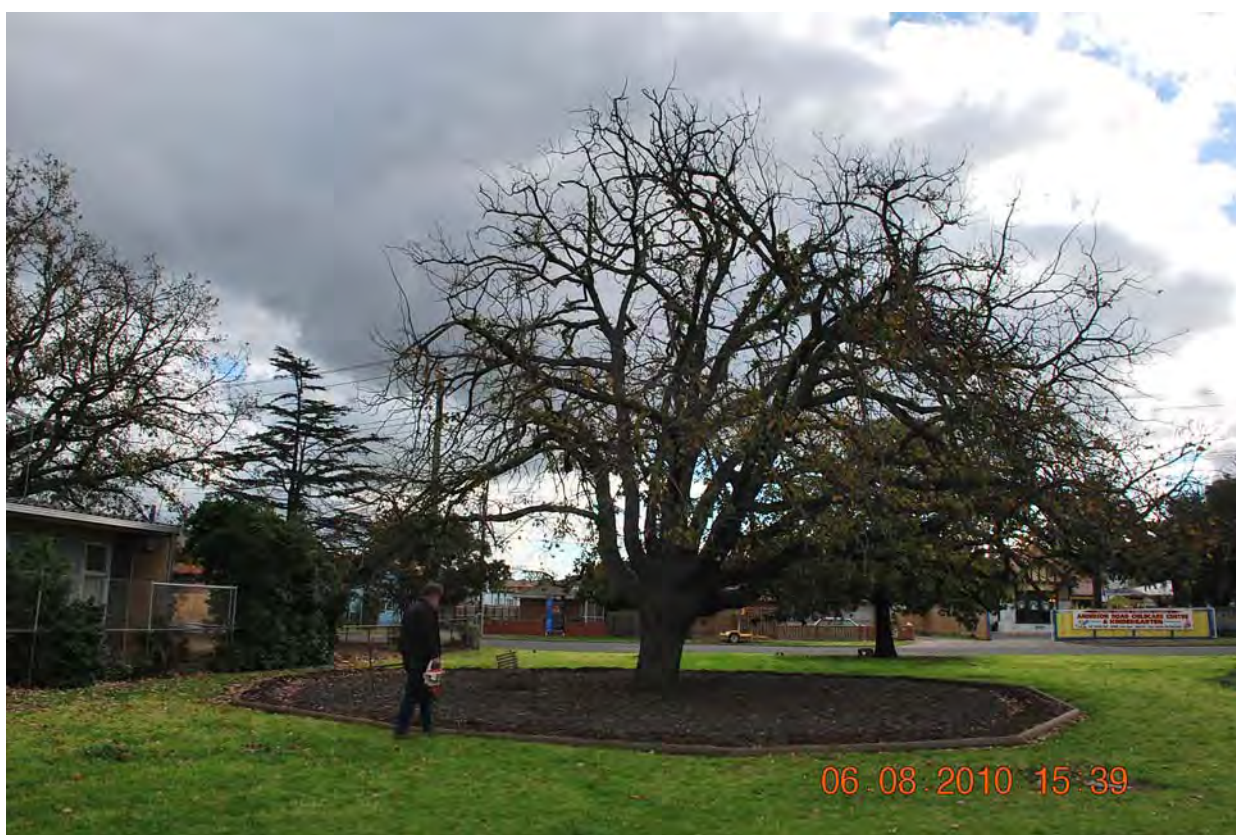
Figure 5: Tree 52400

Tree Number	52400
Botanical Name	<i>Quercus canariensis</i>
Common Name	Algerian Oak
Origin	Exotic
Canopy Dimensions (HxW)	10 m x 18 m
Diameter at Breast Height	87cm
Health	Very Poor
Structure	Good
Useful Life Expectancy	20-40 years
Landscape Contribution	High
Individual Significance	Valuable

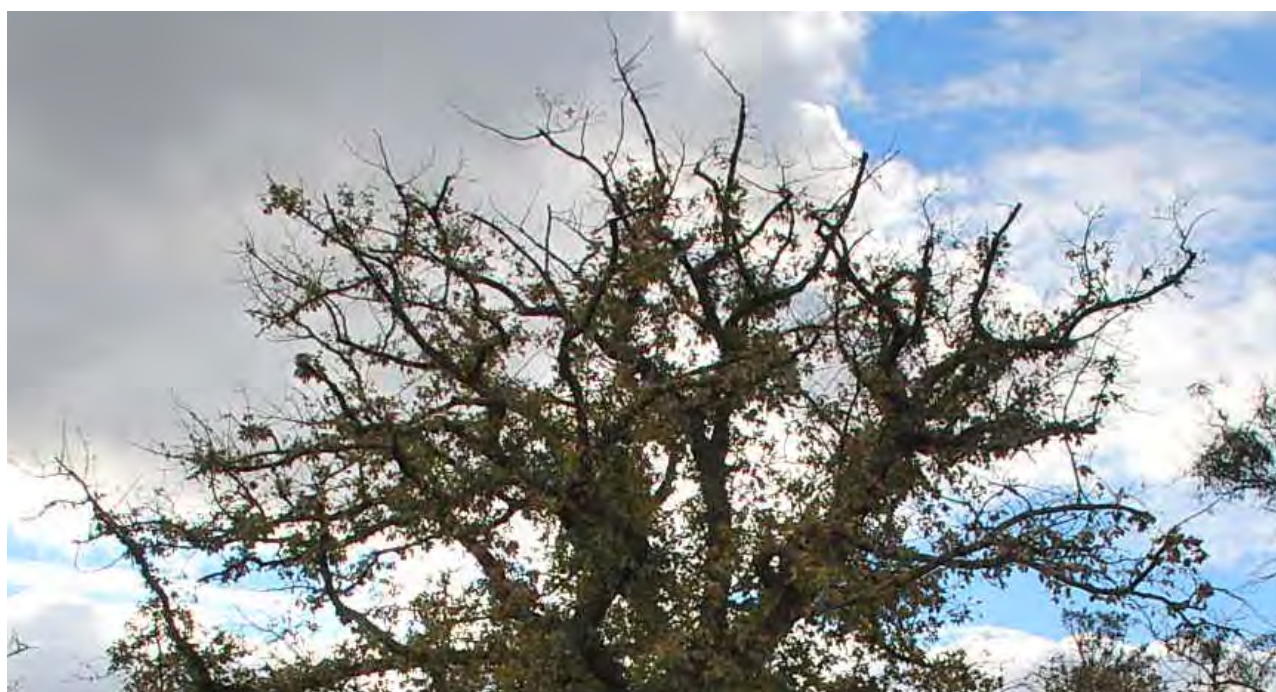
All of the *Quercus canariensis* have reduced foliage size, foliage density, reduction in vigour (extension growth over the last 5 years has dramatically reduced), there is also a highly visible and large volume of small deadwood throughout the canopy. See Figure 6.

Figure 6: Highly visible and large volume of small deadwood in the canopy is an indicator of substantial stress.

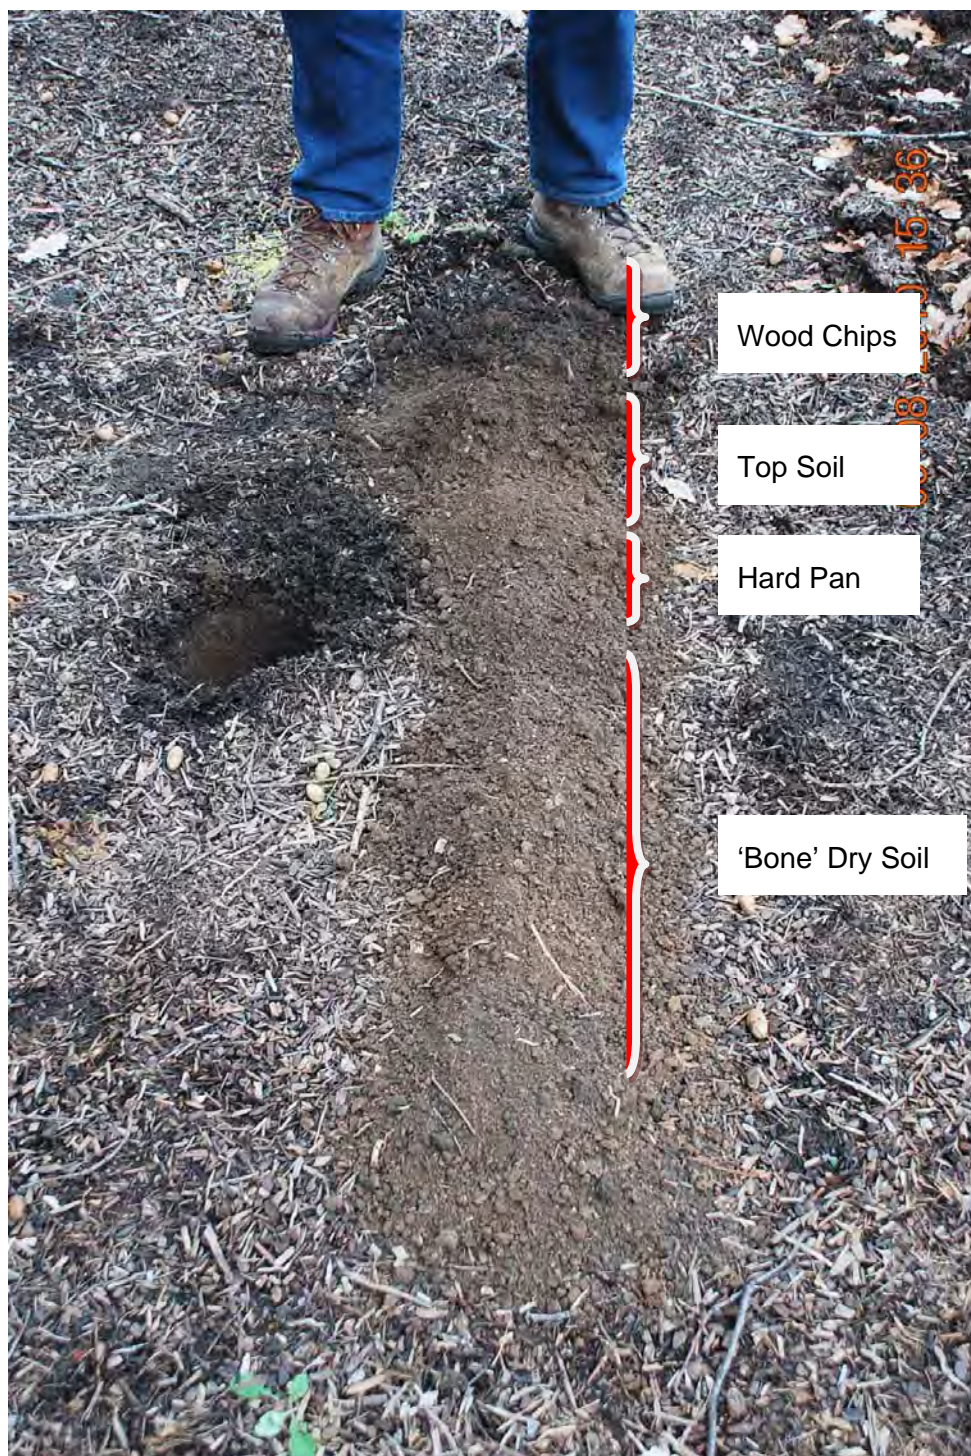
- Top 10-200mm consisted of very loose large wood chips,
- The next 100mm a loose very dry topsoil with minimal root growth
- At 300mm was a very solid hard layer (Hard Pan)
- Beyond the 'Hard Pan', the soil held no moisture and was hydrophobic or 'bone' dry, this layer contained absolutely no root growth. See Figure 11.

Figure 11: Examination of soil profile within McKay Gardens

1. Break up the hard pan under each tree by using a 50mm diameter core drill in 200mm grid pattern to 3.0m beyond the dripline of each tree
2. Irrigate each of the trees with a minimum of 18 000L of water using a soil injection probe
  - 2.1 The soil injection probe will deliver water beneath the 300mm depth hard pan and help break it up
  - 2.2 Include a liquid fertiliser (Nitrogen rich) and seaweed extract to assist with root growth and soil conditioning at manufacturers rates

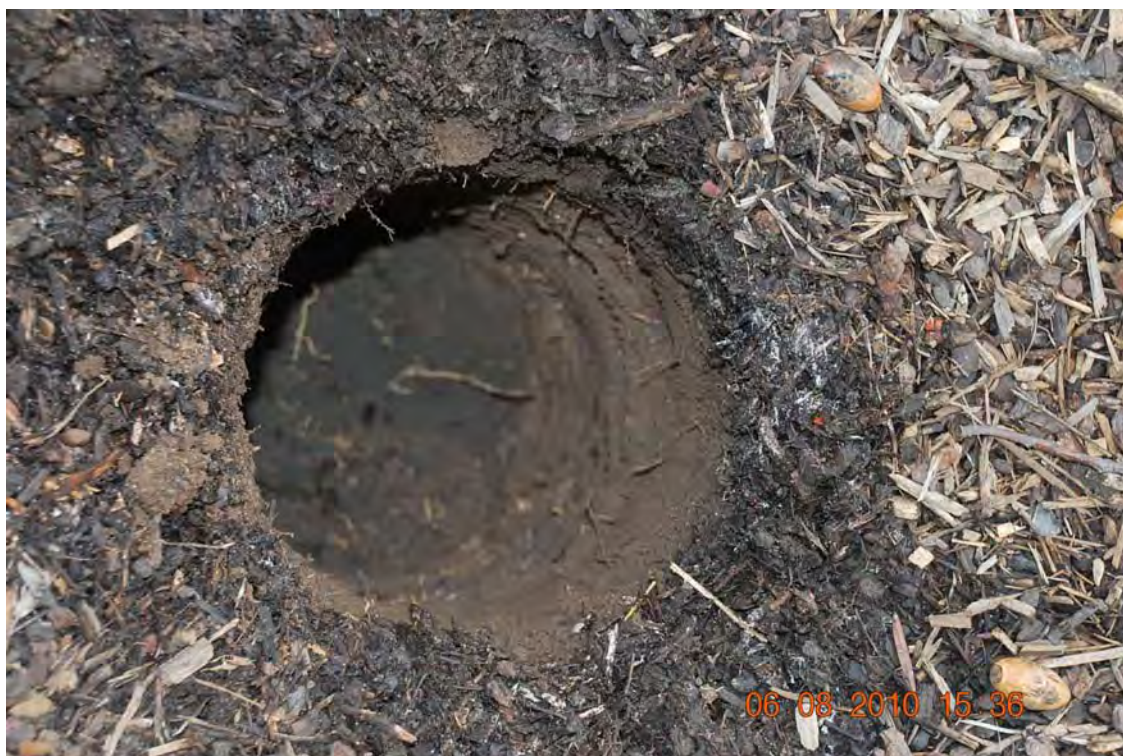
The results of the excavations indicate that most of the finer feeder roots (water and nutrient absorbing roots) are located above the hard pan that is within the top 300mm of the soil profile.

Figure 12: Feeder root growth appears to be only within the top 300mm of the soil profile

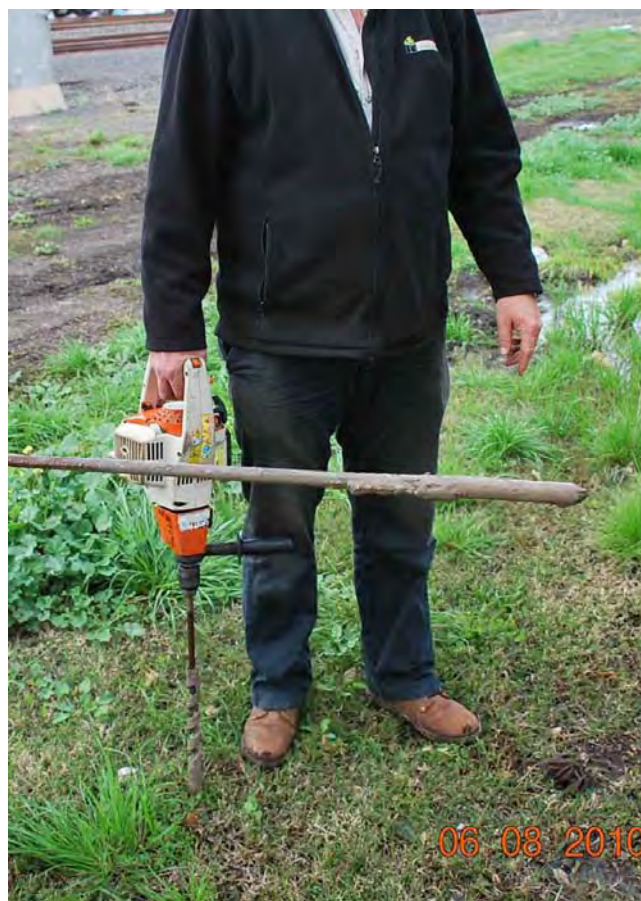
Figure 14: Results from soil drill outside Gardens

The soil excavations undertaken outside the park were completed from within the Railway Reserve. The soil was taken from the upper edge, not within the drainage line yet the soil was completely saturated and looked like 'slurry'.

It appears that there is water available in the soil profile immediately surrounding the gardens but the soil within the park has become compacted and organic matter has been reduced to such an extent that any available water is not absorbed into the soil profile. Most of the water runs off before it can be absorbed.

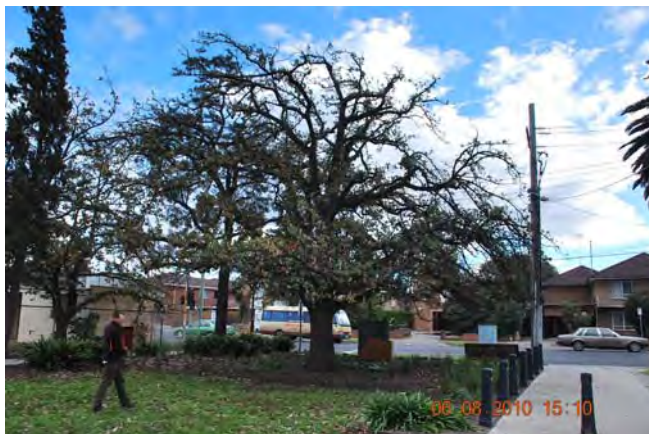
In particular Trees 40311 and 6783 have had one or more pathways constructed within close proximity, or have a driveway or building within close proximity. See Figure 17 and Figure 18. The 'Hard Pan' surrounding all the trees, uncovered during soil excavations is evidence of compaction of the soil profile over a long period.

Figure 17: Tree 6783 has a highly modified soil environment

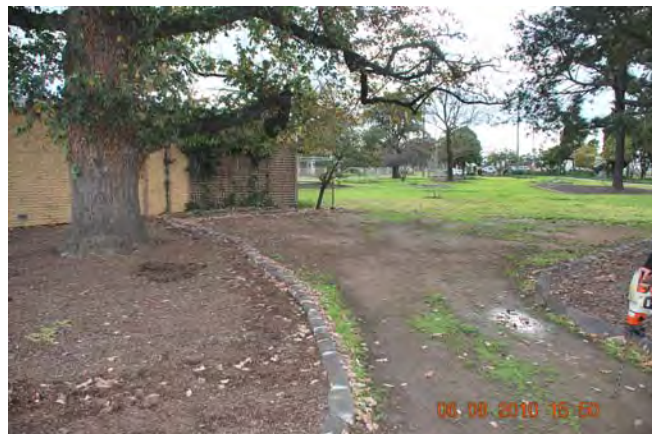
Figure 18: Tree 40311 has a heavily compacted access route directly over its root system

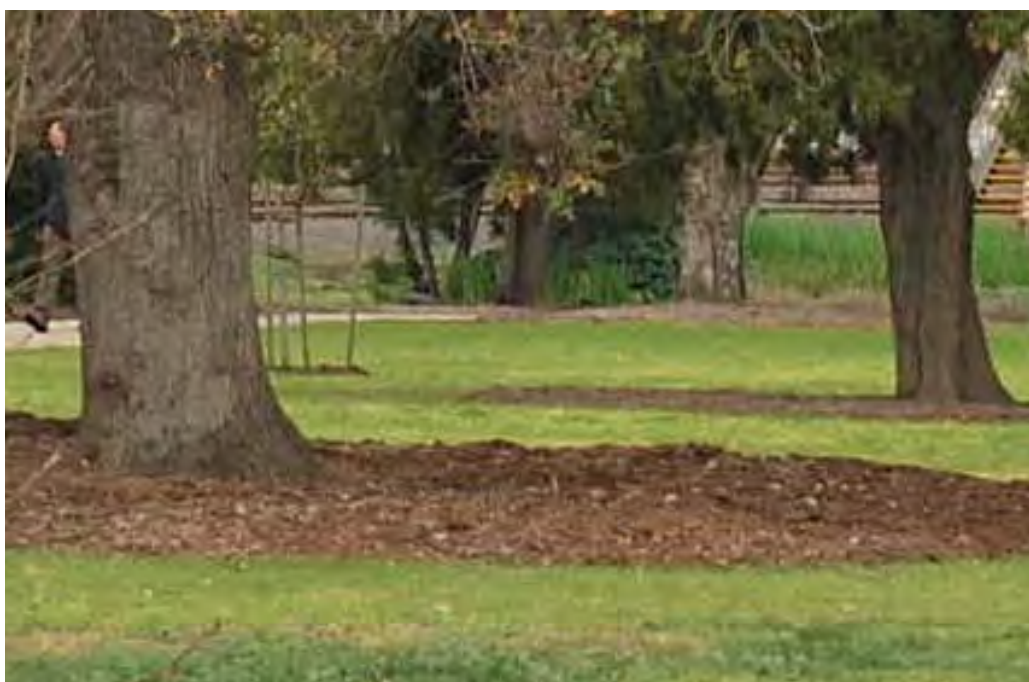
The layer of mulch around this tree in most places exceeds 200mm and it is composed of very large chunks of wood. The soil profile beneath the mulch is extremely dry. The mulch appears to be absorbing any available water preventing the soil from receiving any moisture. See Figure 19.

Figure 19: The mulch under Tree 67888 has a very high wood composition

Due to the composition of the mulch (mainly wood) it is lacking in smaller organic matter, this is preventing it from being broken down to enrich the nutrients in the soil and in fact may be causing what is termed 'Nitrogen Draw Down' where any bacteria or organisms in the soil, battling to break it down take nitrogen out of the soil (Handreck & Black, 2002 and Hitchmough, 1994), causing the tree to further suffer from nutrient deficiencies.
