# Health and Condition Report

## Brimbank City Council

Report on five significant *Quercus canariensis* (Algerian Oak) trees throughout H.V. McKay Gardens, Sunshine

22 November 2010

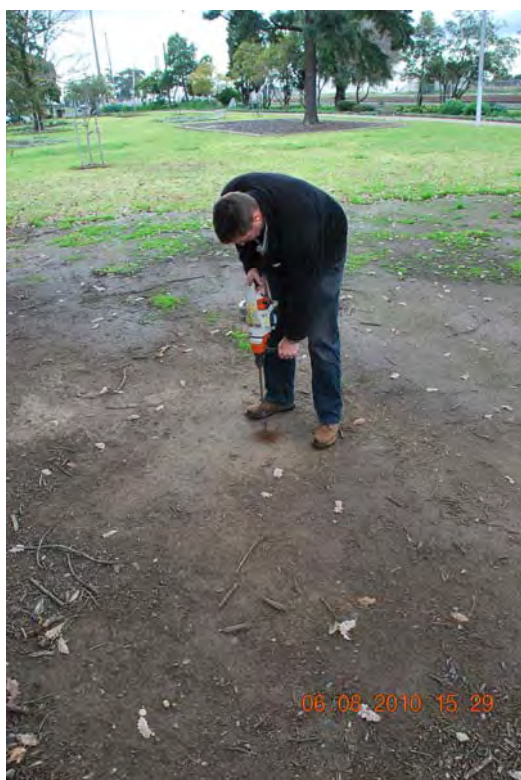
Within and surrounding the canopy within the root zone a grid pattern of holes were bored. The holes were drilled using a using 50mm x 700mm drill bit.

Figure 9: Holes were drilled

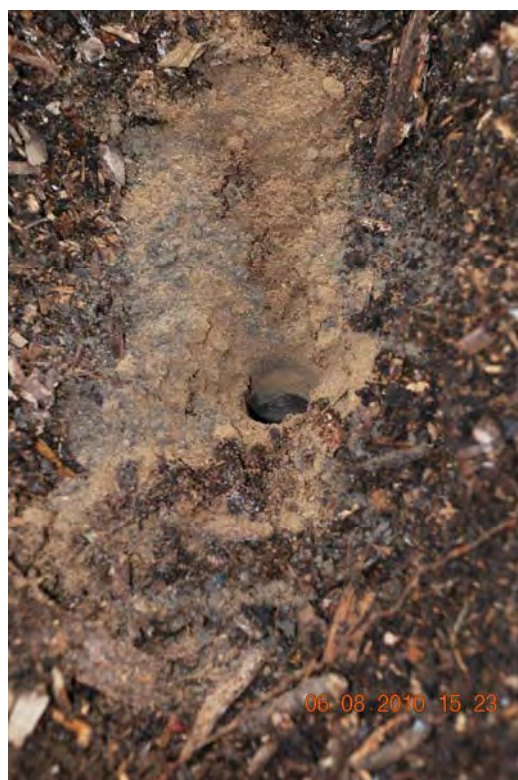
Figure 10: Example of finished hole

- Top 10-200mm consisted of very loose large wood chips,
- The next 100mm a loose very dry topsoil with minimal root growth
- At 300mm was a very solid hard layer (Hard Pan)
- Beyond the 'Hard Pan', the soil held no moisture and was hydrophobic or 'bone' dry, this layer contained absolutely no root growth. See Figure 11.

1. Break up the hard pan under each tree by using a 50mm diameter core drill in 200mm grid pattern to 3.0m beyond the dripline of each tree
2. Irrigate each of the trees with a minimum of 18 000L of water using a soil injection probe
  - 2.1 The soil injection probe will deliver water beneath the 300mm depth hard pan and help break it up
  - 2.2 Include a liquid fertiliser (Nitrogen rich) and seaweed extract to assist with root growth and soil conditioning at manufacturers rates

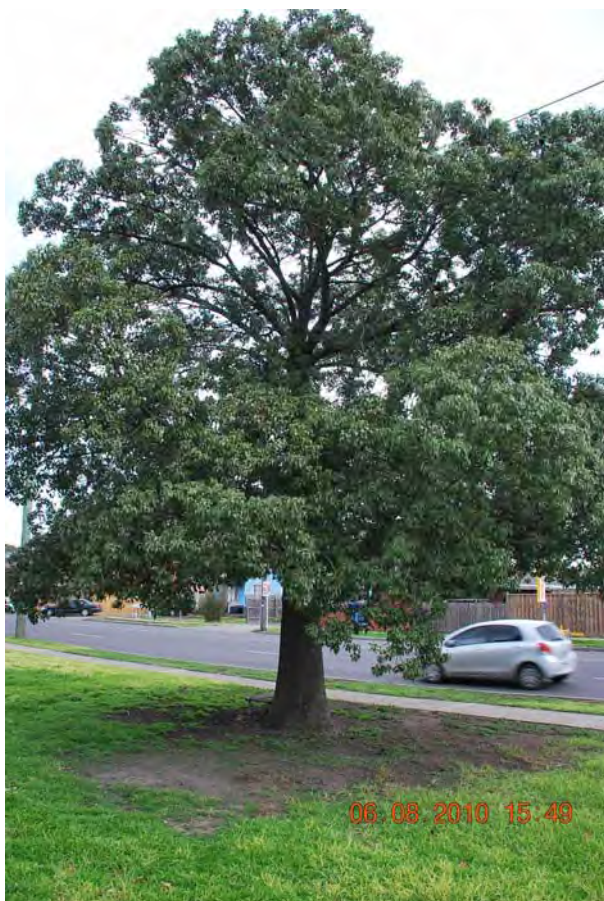
Figure 13: *Brachychiton acerifolia*, Kurrajong

Soil was excavated from underneath a *Brachychiton acerifolia*, near the north west corner of McKay Gardens. The soil conditions beneath the *Brachychiton acerifolia* were the same as those observed underneath the *Quercus canariensis* trees however, the health of the tree is vastly different.

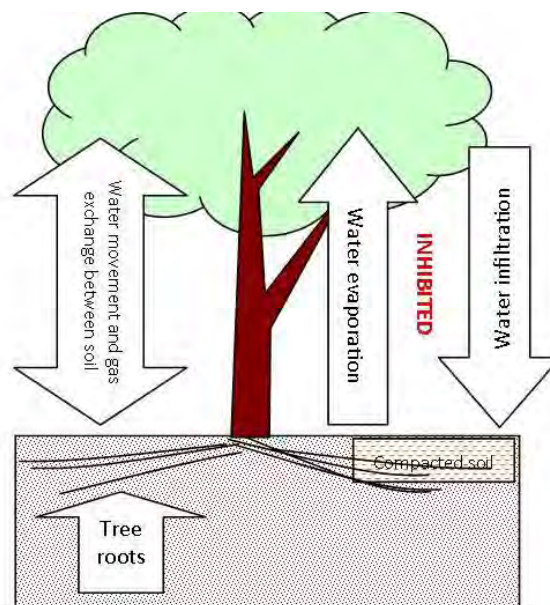
Water infiltration into the soil horizon takes a lot longer. It also inhibits or prevents gas exchange between the roots and the atmosphere. See Figure 15 and Figure 16.

Figure 16: Compacted soil
